APOLLO 14 MISSION
ANOMALY REPORT NO. 5

APOLLO 15 MISSION
ANOMALY REPORT NO. 2

INTERMITTENT STEERABLE ANTENNA OPERATION

MANNED SPACECRAFT CENTER
HOUSTON, TEXAS
OCTOBER 1972

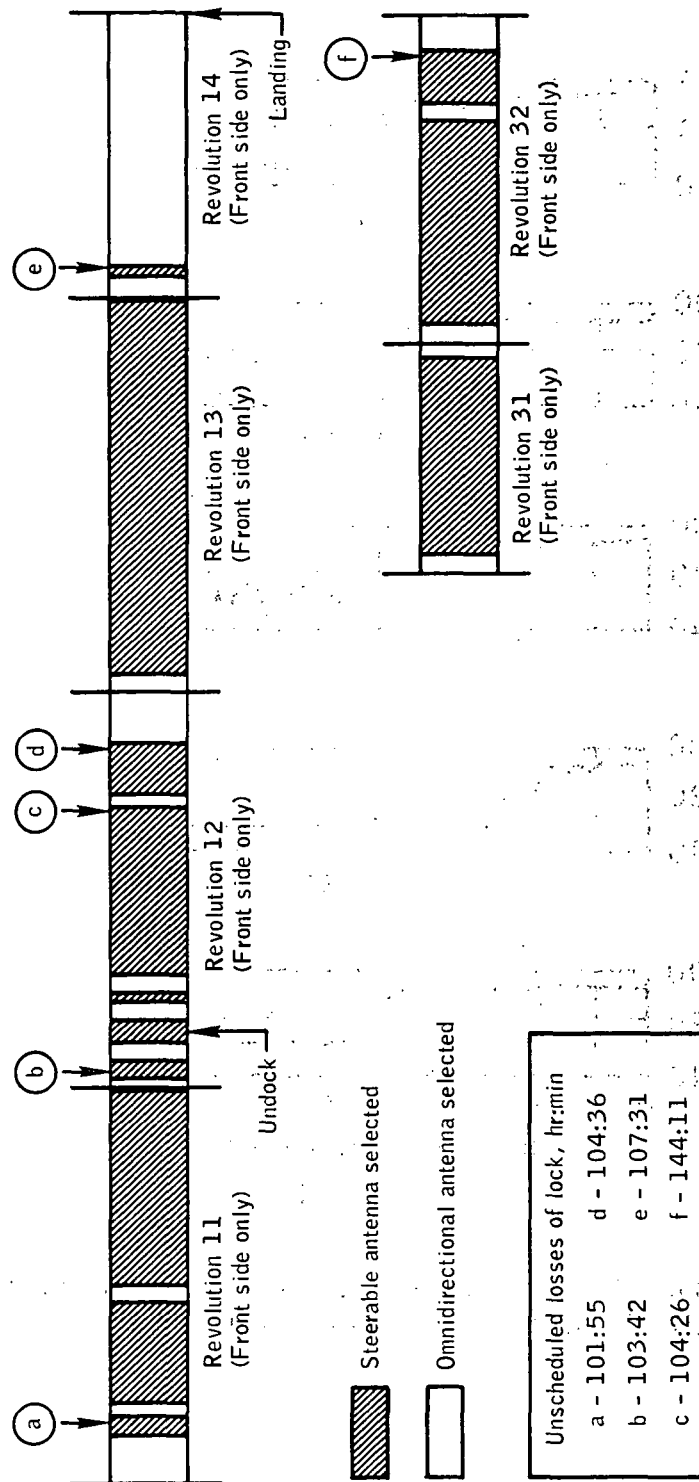
Figure 8.- Unexplained tracking interruptions during Apollo 14.

There were six unexplained interruptions of antenna tracking during Apollo 14 and one during Apollo 15. Five of the Apollo 14 interruptions and the Apollo 15 interruption occurred prior to powered descent. The final Apollo 14 interruption occurred after ascent from the lunar surface, but prior to rendezvous. Random antenna oscillations occurred on all Apollo lunar landing missions where the antenna was used.

All six unexplained Apollo 14 tracking interruptions (fig. 8) have similar characteristics. Five of the interruptions occurred during coverage by the Goldstone tracking station, and figure 9 shows the ground-station-received signal strengths at these times. During the coverage of revolution 32, another incident was noted with the same type of antenna response. The response indicates that the antenna began to experience approximately 2- to 3-hertz mechanical oscillations which became increasingly larger in amplitude with time. When the oscillations exceeded 10 degrees peak-to-peak, excessive drive-motor current caused the circuit breaker supplying 28 volts dc to the motors to open. The antenna was also reported to be noisy, indicating the continuous driving that occurred during the oscillations. The oscillations occurred randomly at other times during the problem period, but damped out without causing tracking interruptions. Similar oscillations occurred during the Apollo 11, 12, and 15 missions, but only Apollo 15 and 16 experienced tracking interruptions. Figure 10 shows typical signal strength variations associated with damped antenna oscillations for Apollo 15.

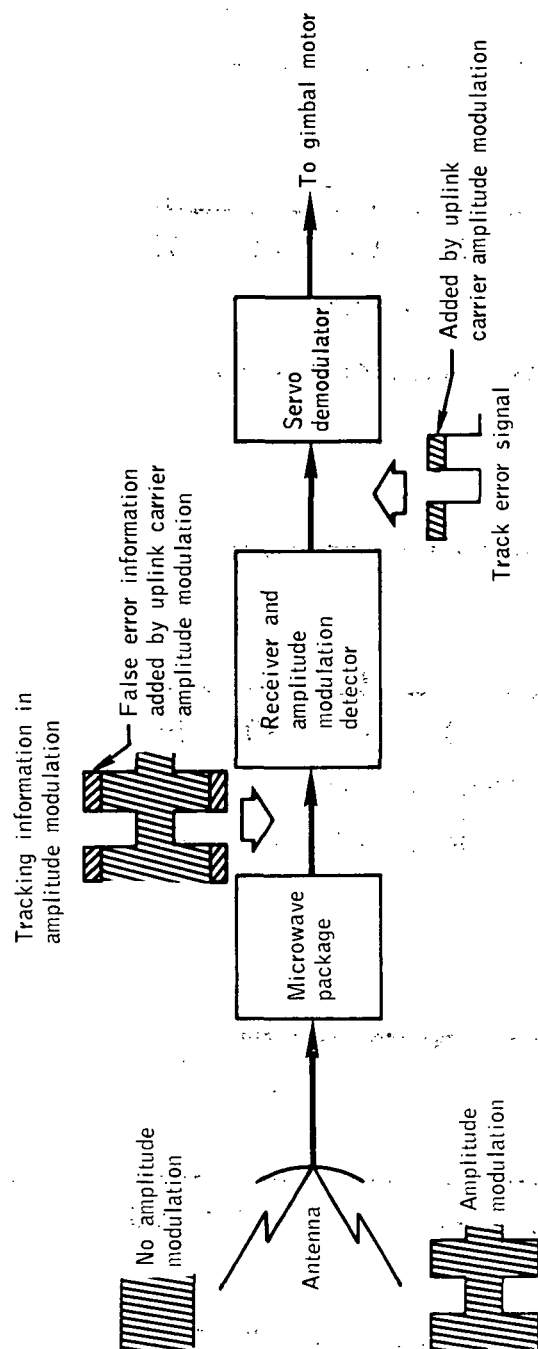
Figure 11.- Result of uplink carrier amplitude modulation.

- a. Amplitude modulation on the uplink radio frequency carrier (fig. 11).
- b. Noise capacitively or inductively coupled into the track error line (fig. 12).
- c. Hardware problems resulting in tracking loop instabilities.

Tests have shown that very small amounts of amplitude modulation on the S-band carrier (0.5 percent) near the 50-hertz antenna-lobing frequency will cause the antenna to oscillate and lose track. These same effects were also found at 16, 25, 33, 100, and 150 hertz, but to a lesser degree.

Amplitude modulation of the uplink signal can be caused either by vehicle blockage or uplink signal multipath (reflections) from spacecraft structure, the lunar surface, or reaction control system engine plumes. Some amplitude modulation also exists on the uplink signal transmitted by the ground antenna, and varies with the uplink mode being used; however, this is normally less than that required to cause significant oscillations.

The following actions were taken for the Apollo 15, 16, and 17 spacecraft to help minimize any contribution of incidental amplitude modulation of the uplink signal to antenna instability. Uplink modes having the lowest incidental amplitude modulation are being used whenever possible, and all tracking stations have been modified to incorporate subcarrier oscillators with very low amplitude modulation.

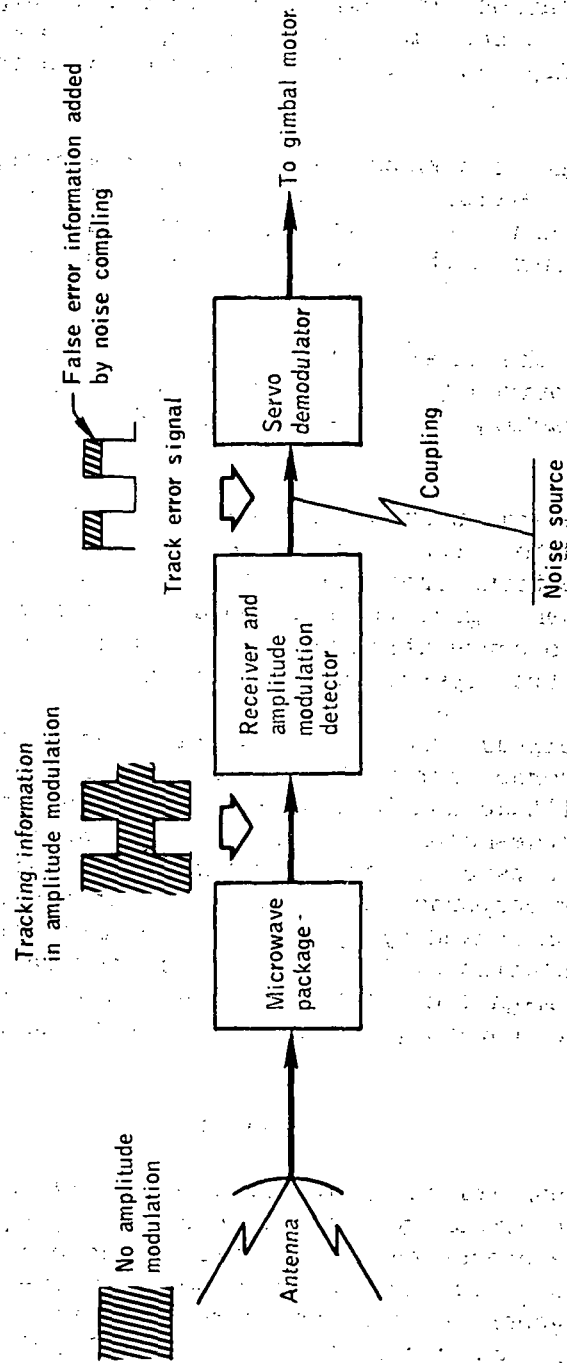
Figure 12.- Result of noise coupled into track error line.

There is the possibility that noise could have been coupled into the antenna or receiver circuitry from other operating equipment. Of all the spacecraft hardware operating at the time of the oscillations, only three pieces of equipment could have produced noise at the required frequencies. However, none can generate noise anywhere close to 740 volts ac (capacitive coupling) or 18 amperes ac (inductive coupling) required to couple sufficient energy to create oscillations in the antenna circuits.

A special test was performed on the Apollo 16 lunar module to check noise coupling into the antenna circuits. The tracking loop error voltage was monitored while all other spacecraft electrical systems were operated and no detectable interference occurred.

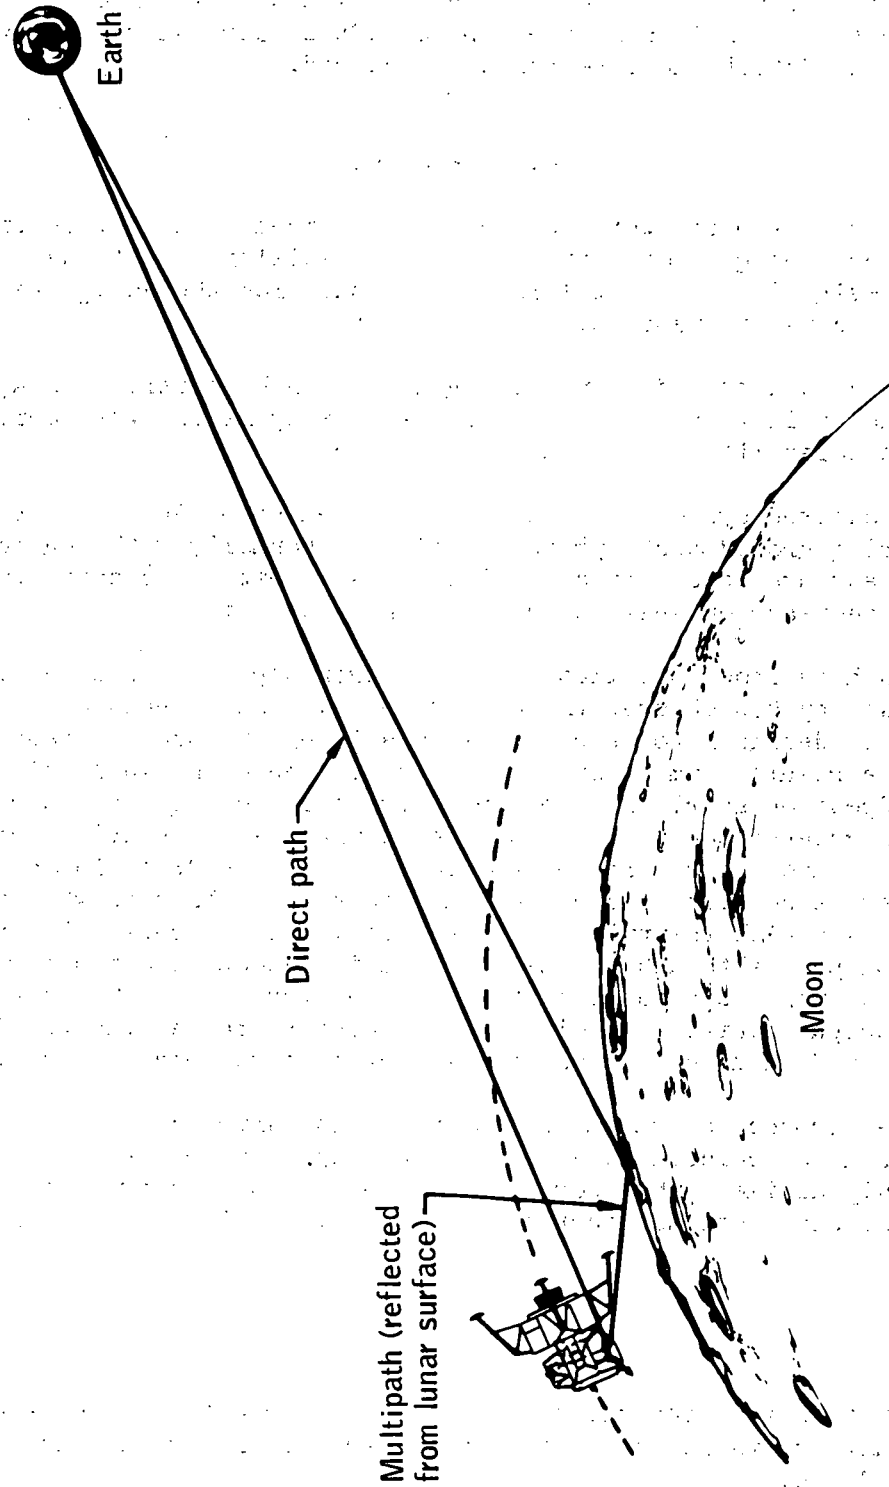
Figure 13.- Example of multipath signal reflection from lunar surface .

Multipath from the lunar surface normally occurs when the spacecraft is near the lunar horizon (fig. 13) and can cause oscillations; however, oscillations and tracking losses also occurred without multipath conditions.
